REPORT ON OBSERVATIONS AT THE BATH VILLAGE BRIDGE BATH, NEW HAMPSHIRE

JAMES L. GARVIN
SEPTEMBER 18, 2008

This report is based on observations made at the Bath Village Bridge on September 16, 2008. The inspection was made as part of a broader bridge evaluation by Sean James and Josif Bicja of Hoyle, Tanner & Associates, consulting engineers, assisted by crew members from Wright Constriction Company of Mount Holly, Vermont. The purpose of the Hoyle, Tanner inspection was to provide an update to their submitted in April 2006. The purpose of the Division of Historical Resources' inspection was to determine the condition, integrity, and evolution of the bridge in order to be prepared to apply the *Secretary of the Interior's Standards for the Treatment of Historic Properties* in any future review of proposals for treatment of the bridge.

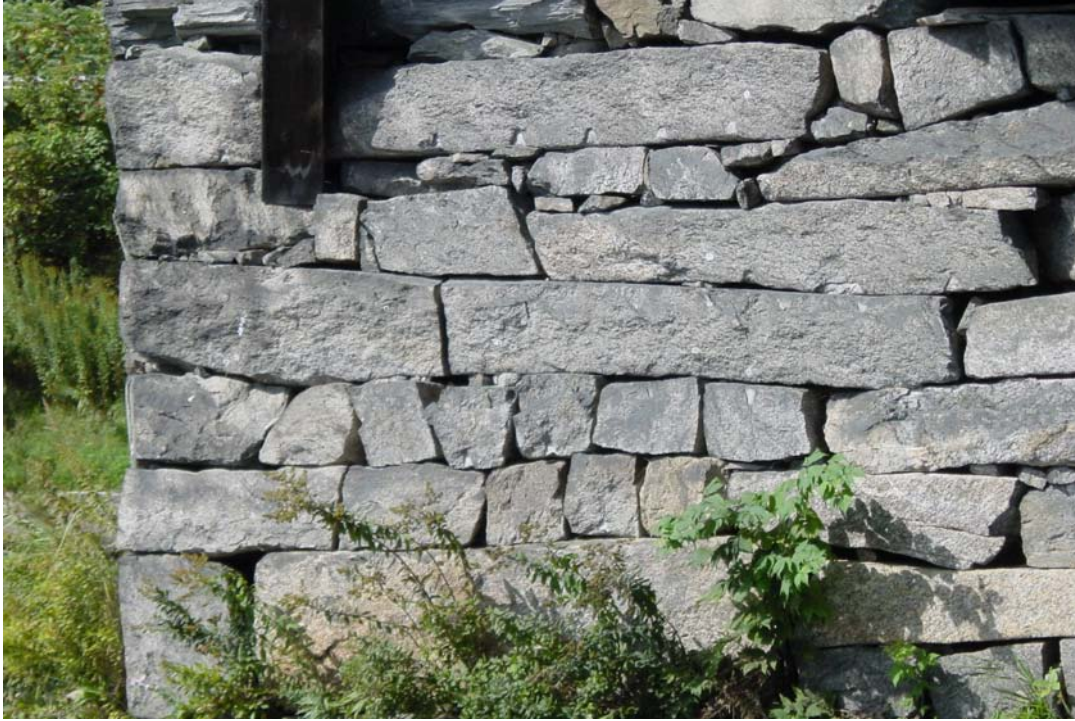
The same splitting technique is clearly visible in both Pier 1 and Pier 2 of the Bath Village Bridge.

Detail of east face of Pier 2, Bath Village Bridge

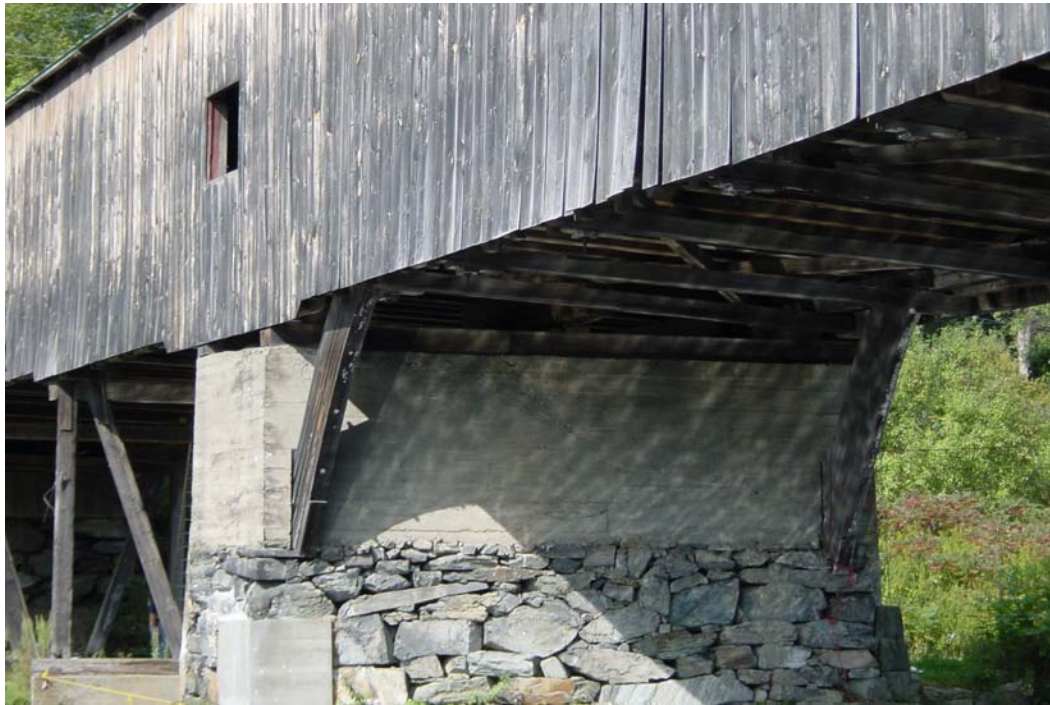
By contrast, Pier 3 has fewer large split stones than Piers 1 and 2:

East face of Pier 3, Bath Village Bridge

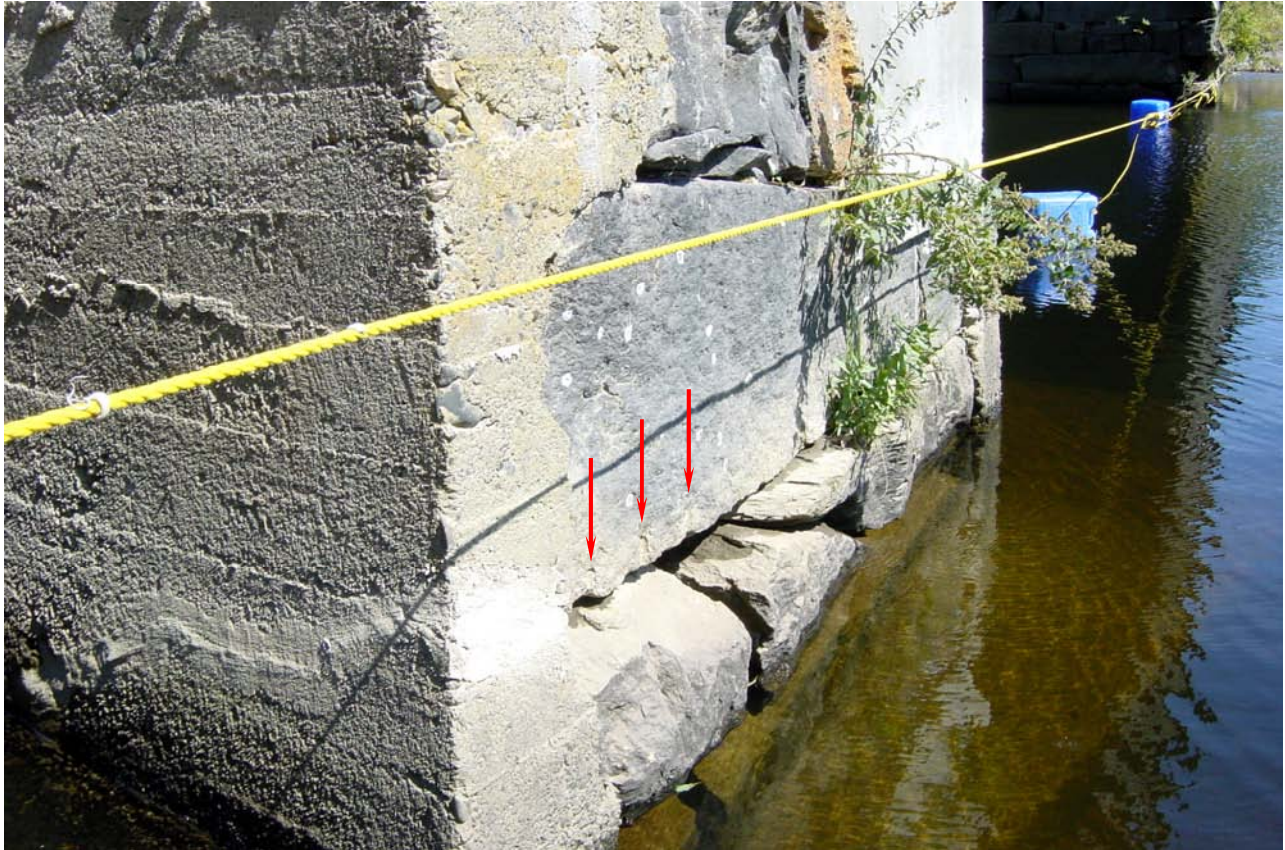
While Pier 3 shows less evidence of splitting techniques, one of the lowest stones in this pier, clearly original, displays the marks of the plug drill, denoting its later date:

South face of Pier 3, Bath Village Bridge

Although stone splitting evidence confirms the long-held belief that Pier 3 was added beneath the center of Span 3 after completion of the bridge, this physical evidence cannot suggest how much later the pier was added. Because the flat-wedge method of splitting granite was supplanted by the plug-and-feathers method soon after the bridge was built, Pier 3 could date anywhere from a few years after completion of the span up to around 1910, when concrete supplanted stone masonry for most work. Although the stonework of Pier 3 is too crude to suggest railroad construction of the latter nineteenth century, it is possible that this pier was added to the bridge when tracks first passed under the bridge in 1852-3. It is possible that this pier was not originally built to the height of the others, but that it supported a wooden trestle that extended up to the bottom chords of the bridge.

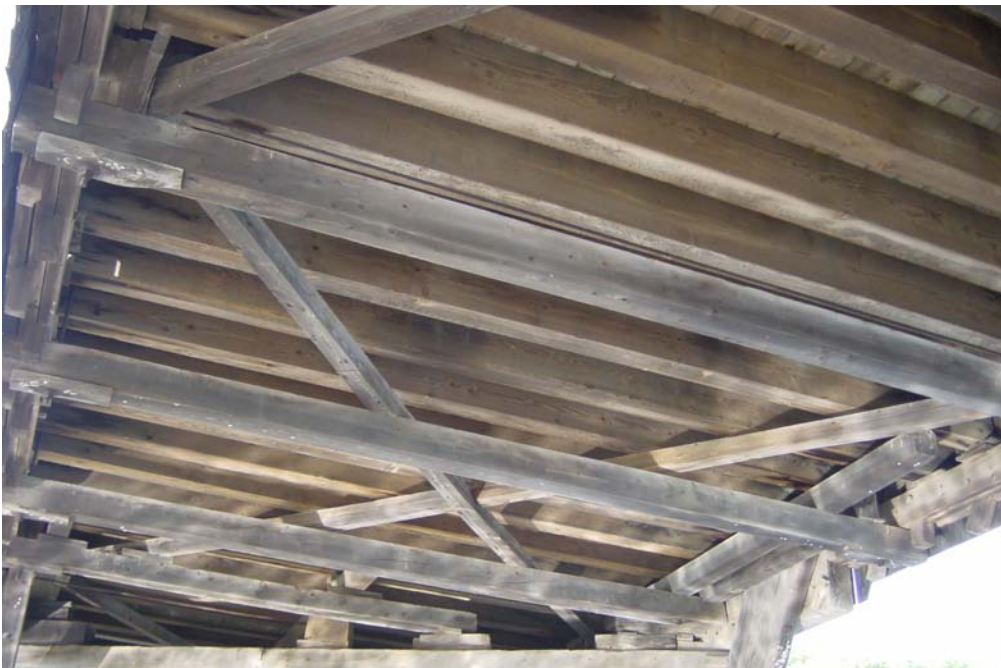
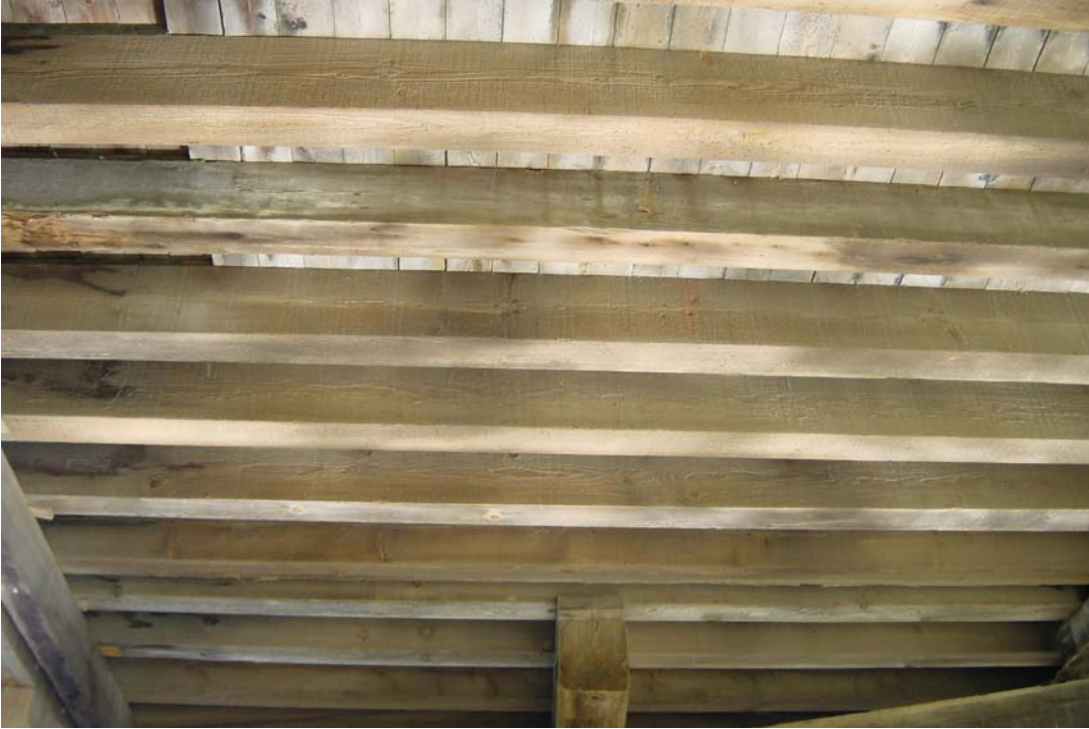
Observations made from the available vantage points suggest that all of the floor beams now in the bridge are of recent date. Some existing beams appear to predate the rehabilitation of 1987-88. Those beams that were found to be sound in 1987-88 appear to have been turned over to allow new floor planking to be nailed into the sound wood of what had been the bottoms of the beams.

The majority of beams now seen in the bridge, however, appear to have been installed in 1987-88 above older needle beams and lower lateral bracing:

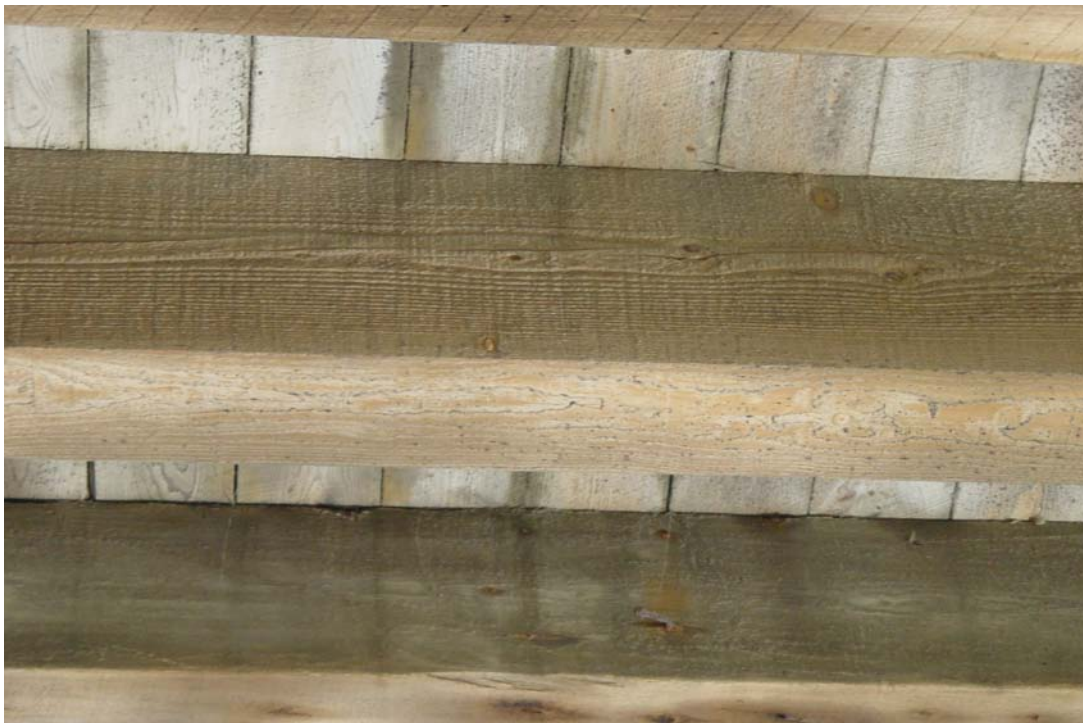
The new floor beams of 1987-88 appear to have been band-sawn on their sides, and cut to depth on a circular sawmill, leaving curved saw marks on their soffits, as seen below:

Bottom: re-used floor beam. Middle and top: band-sawn floor beams sawn to depth on a circular saw
