REPORT ON OBSERVATIONS AT THE BATH VILLAGE BRIDGE BATH, NEW HAMPSHIRE

JAMES L. GARVIN
SEPTEMBER 18, 2008

This report is based on observations made at the Bath Village Bridge on September 16, 2008. The inspection was made as part of a broader bridge evaluation by Sean James and Josif Bicja of Hoyle, Tanner & Associates, consulting engineers, assisted by crew members from Wright Constriction Company of Mount Holly, Vermont. The purpose of the Hoyle, Tanner inspection was to provide an update to their submitted in April 2006. The purpose of the Division of Historical Resources' inspection was to determine the condition, integrity, and evolution of the bridge in order to be prepared to apply the *Secretary of the Interior's Standards for the Treatment of Historic Properties* in any future review of proposals for treatment of the bridge.

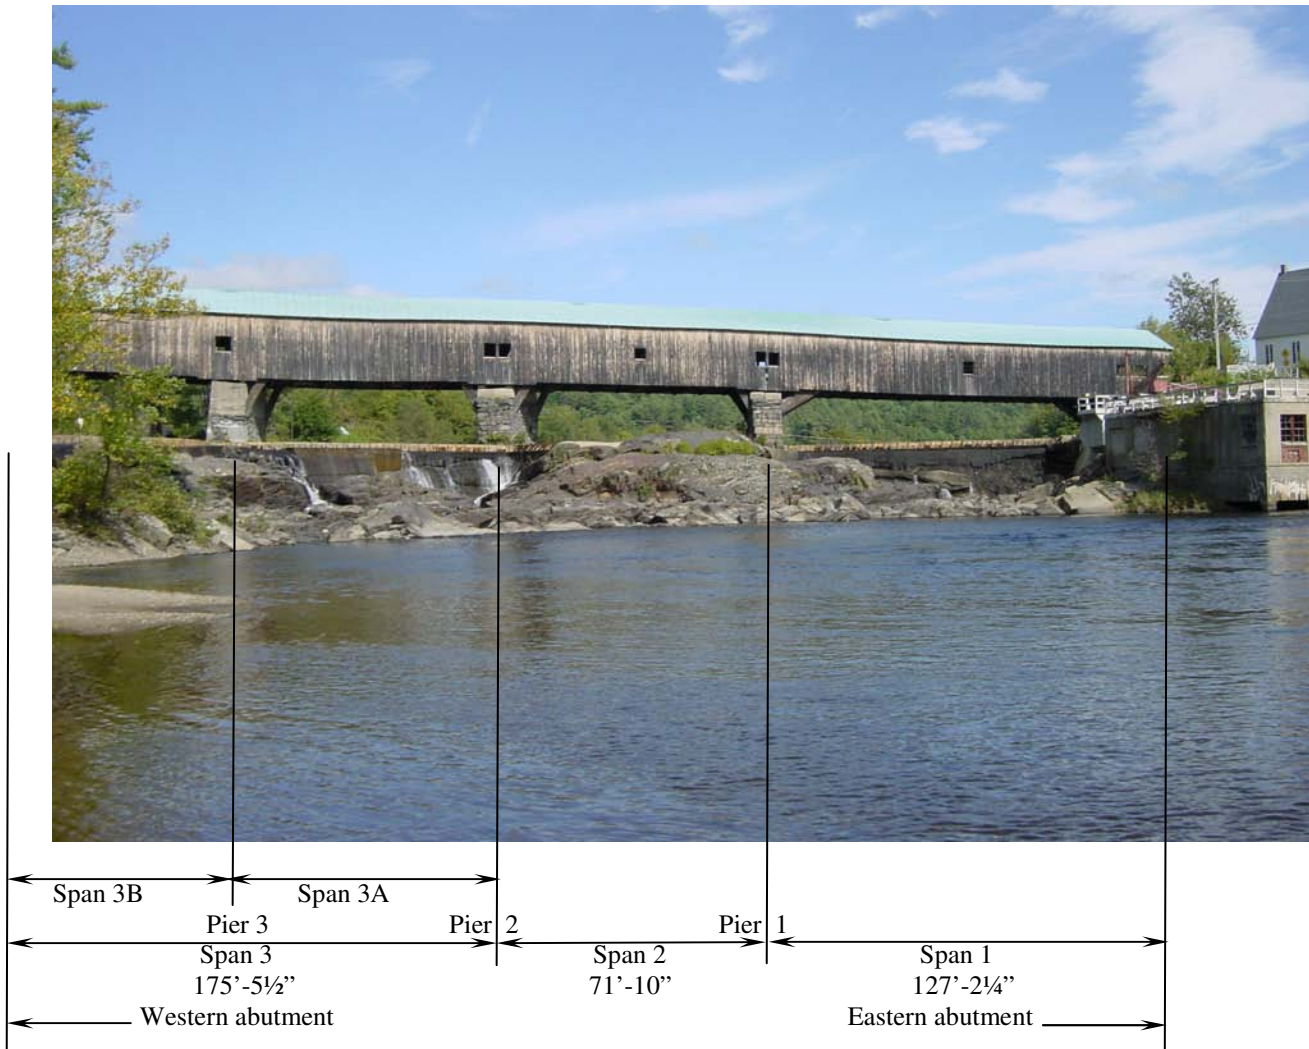
The Bath Village Bridge is composed of three original spans of widely varying lengths. The bridge has apparently not been measured along its centerline, and the different angles of the abutments and the piers causes the upstream and downstream trusses in each span to display differing lengths. The HAER report mentioned above gives the total truss length of Bath Village Bridge as 374'-5¾" at the floor. The length of the east span is 127'-2¼" on the upstream side. The center span is 71'-10" in length, while the long original west span (now subdivided by an added pier at its center) was 175'-5½" long.

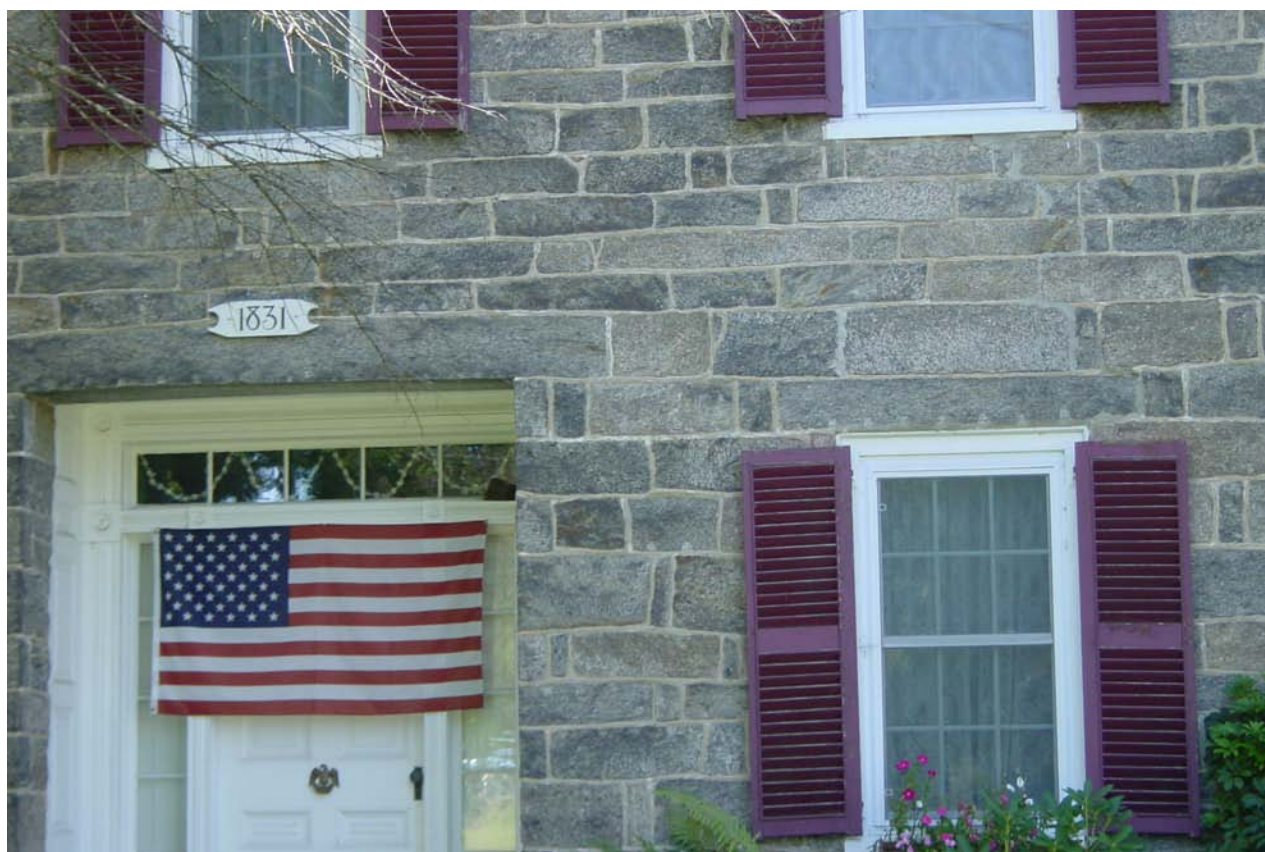
The fact that flat-wedge granite splitting was still being used in Bath in 1831, the year in which the two original piers were built, is verified by the William Vance Hutchins House, a granite dwelling of 1831 that stands a short distance from the bridge. As seen above the doorway and window in the photograph below, the walls of this building clearly show evidence of flat-wedge splitting.

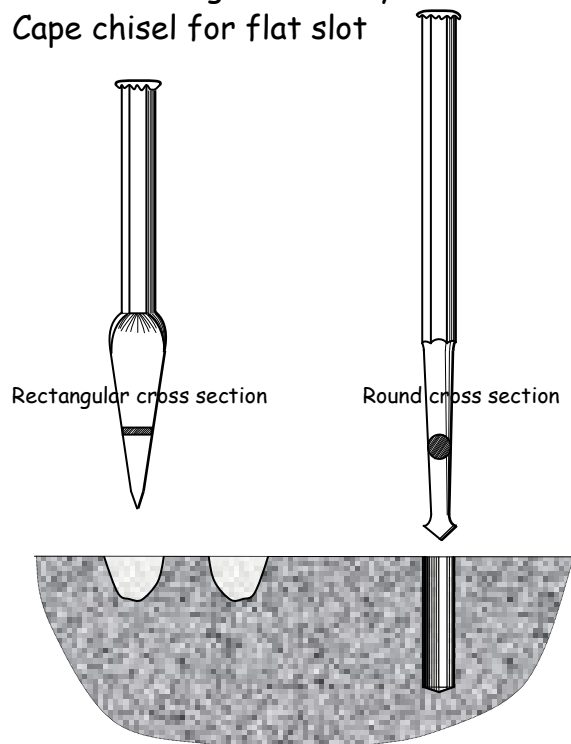
Plug drill for cylindrical hole
Cape chisel for flat slot

Prior to about 1830, the procedure for splitting granite entailed the cutting of a line of shallow slots in the face of the stone, using a tool called a cape chisel, struck with a heavy hammer. Small, flat steel wedges were placed between shims of sheet iron and driven into these slots, splitting the stone. The new splitting method of circa 1830 used a “plug drill,” which had a V-shaped point and was rotated slightly between each blow of the hammer, creating a round hole two or three inches deep.

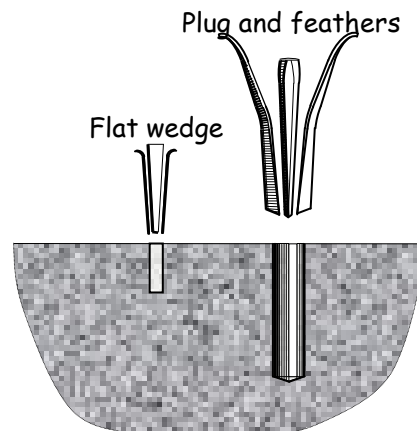
Into this hole were placed a pair of half-round steel shims or “feathers,” and between these was driven a wedge or “plug” which exerted outward pressure and split the stone. The advantage of the “plug-and-feathers” method of splitting was the greater depth within the stone at which the wedges exerted their pressure, thus allowing larger pieces to be split more accurately.

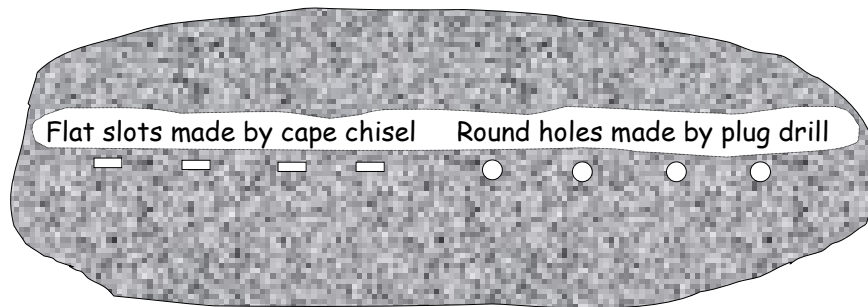
When seen on the surface of a stone that was prepared for splitting but never split, these slots or holes appear as shown below:
